Report on the investigation of  
the fatal accident to person on board

***Thomson Celebration***

***Tender 15***

**Report No 11/2007  
June 2007**

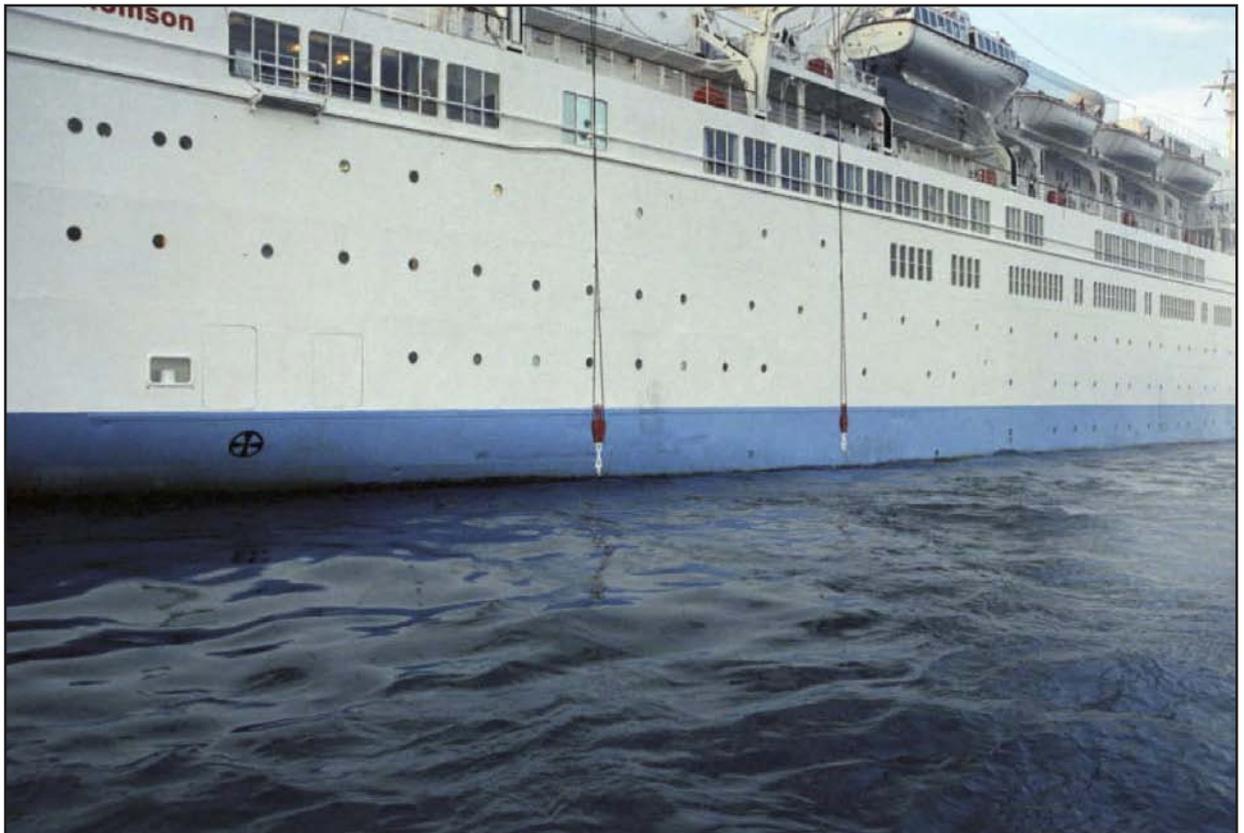
Figure 3

Tender operations commenced soon after *Thomson Celebration* had been anchored. Three of the vessel's four tenders were launched and then used to transport the passengers. The fourth tender was out of service with a mechanical fault on one of its two engines. After the tenders were clear of the ship's side, the davit fall blocks were left hanging close to the water (**Figure 3**).

Davit fall blocks

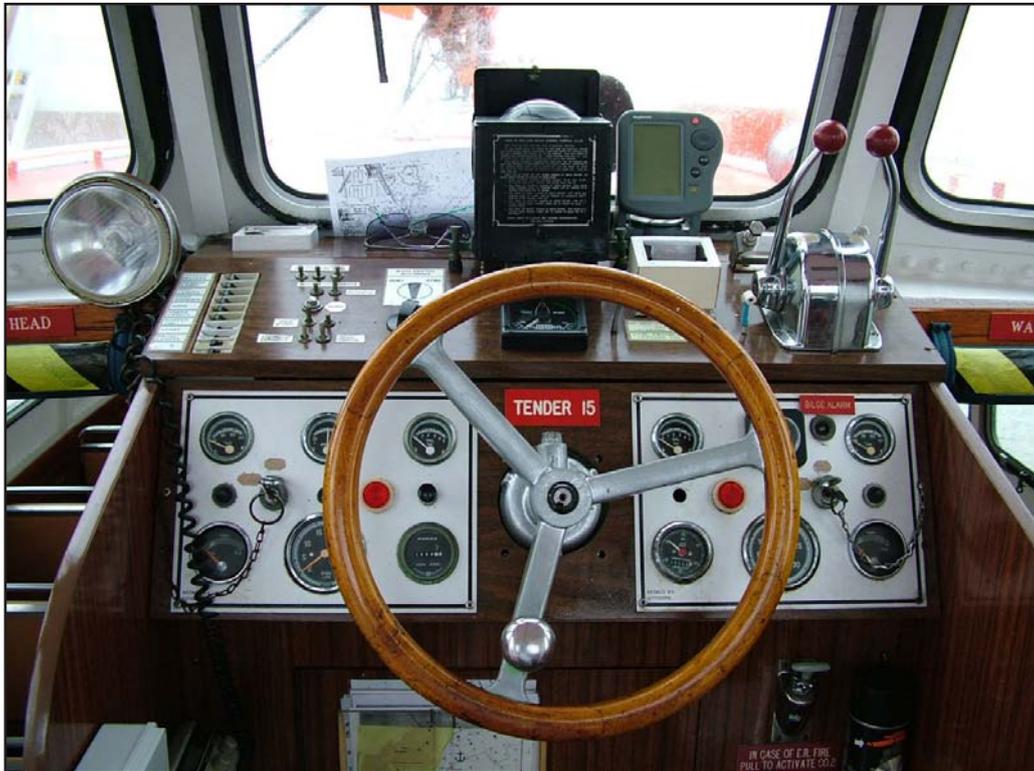
Controls, *Tender 15*

*Tender 15* remained in operation with an oil leak from the steering system that caused progressively poorer rudder response. Before the accident, the steering was reported to be 'loose' and required an excessive amount of turns for the rudder to respond. This was noted at the coxswain's handover, as was the fact that the rudder indicator was inoperative. The accepted procedure to inform *Thomson Celebration's* bridge of any mechanical problems affecting the passenger tenders when in service, was not followed, and the bridge was therefore unaware of these problems.

loss of oil from the *Tender 15* steering system. His records indicate that the initial fault finding traced the leak to a drain plug. After the accident, the piping system was fully

inspected and the leak was found to be at a weld. The size of the weld fracture had probably increased over time, leading to more oil loss and leading to the need for more frequent topping up of the system.

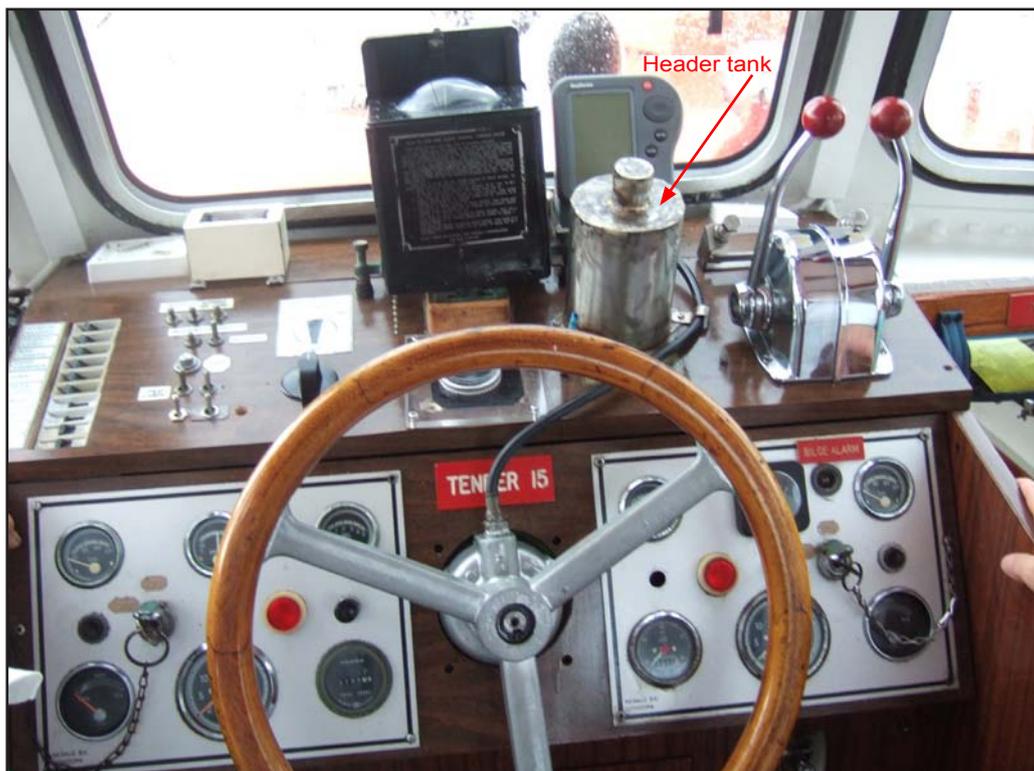
Controls, *Tender 15* - with oil header tank fitted

After the accident, the fitter developed his own solution to the oil loss by manufacturing and fitting a header tank in the tender wheelhouse. The officer responsible for the maintenance of the tenders was unaware of this modification (**Figures 7 and 8**).

- 2007/152      **Lloyd's Register of Shipping** is recommended to:  
Propose and develop within IACS agreed standards for the issuing of lifeboat/passenger tender certificates.
- 2007/153      **The Maritime and Coastguard Agency (MCA)** is recommended to:  
Recognising the need for additional training, to achieve a level of competence appropriate to operating large capacity passenger tenders, develop and take forward to IMO, through the most appropriate channels, competency requirements for passenger ship tender coxswains and crew.
- 2007/154      **Columbia Ship Management Ltd** is recommended to:  
Put in place and enforce procedures that will prevent unauthorised maintenance being carried out on passenger tenders.

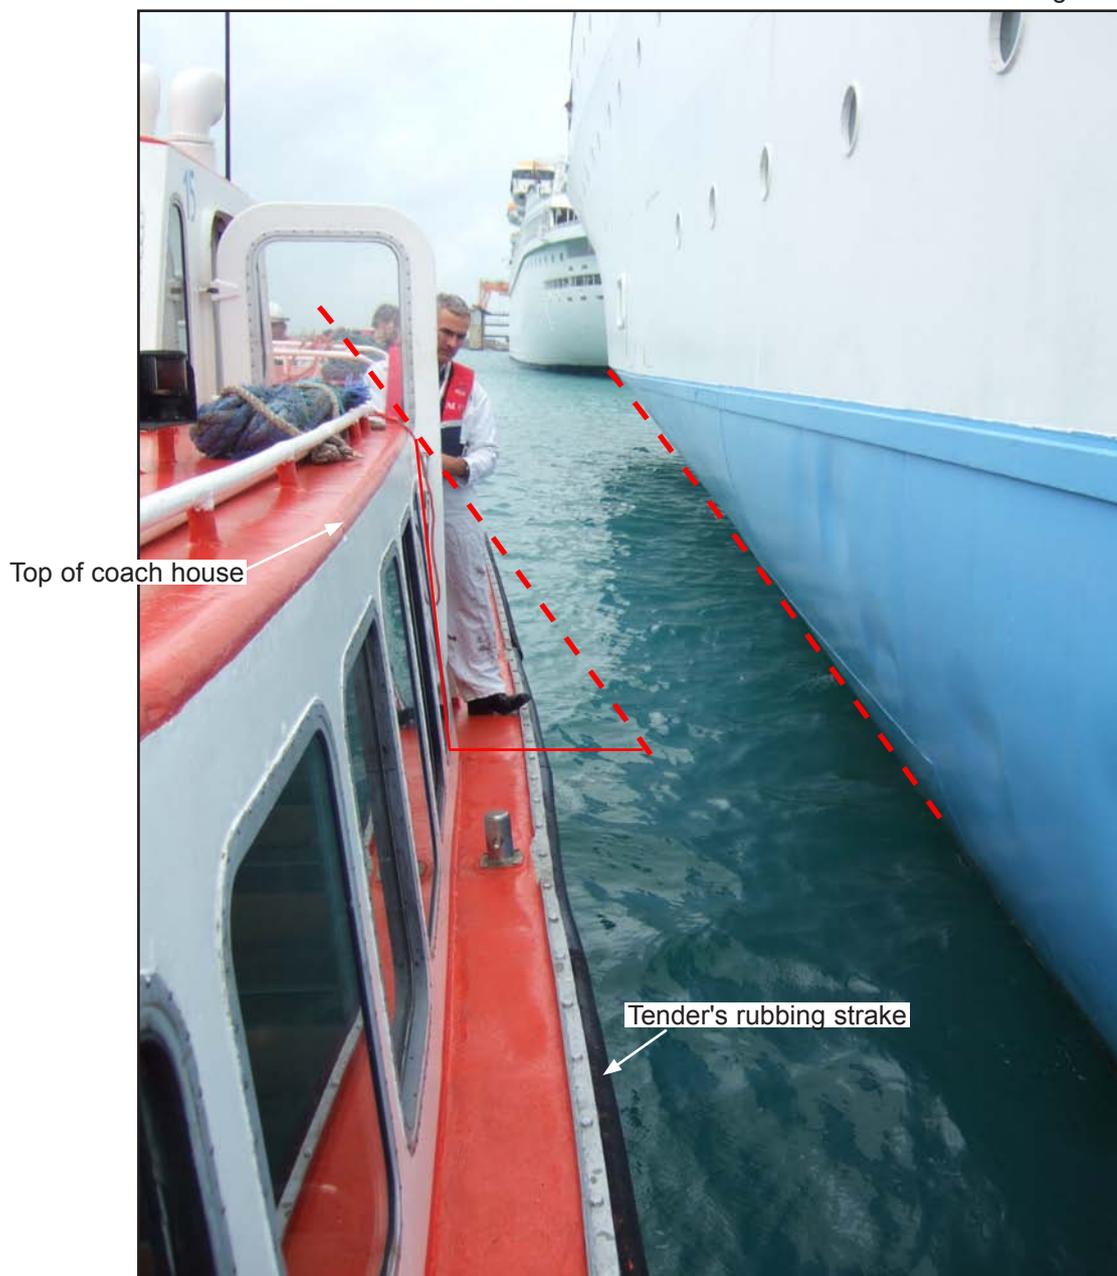
Figure 9

If *Tender 15* had been located further forward, where there was no curvature of the hull at the waterline, it is probable that the accident would not have occurred. Given the frequent use made of passenger tenders on *Thomson Celebration*, manoeuvring of the boats to the falls during recovery operations would be significantly easier in such a position, especially in tidal conditions.

Photograph showing the curve of the ship's side at the position of the accident (dotted parallel lines indicate the coach house will strike the vessel's hull before the tender's rubbing strake)
