Report on the investigation of  
the fatal accident to person on board

***Thomson Celebration***

***Tender 15***

**Report No 11/2007  
June 2007**

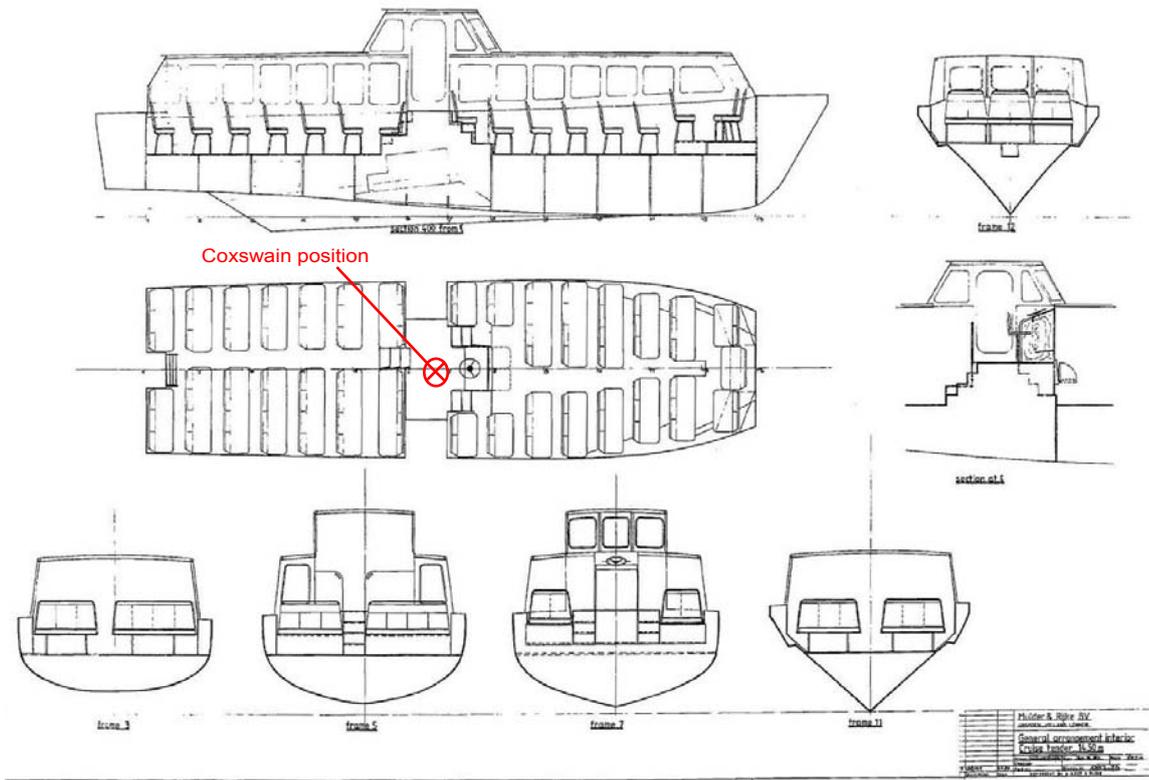
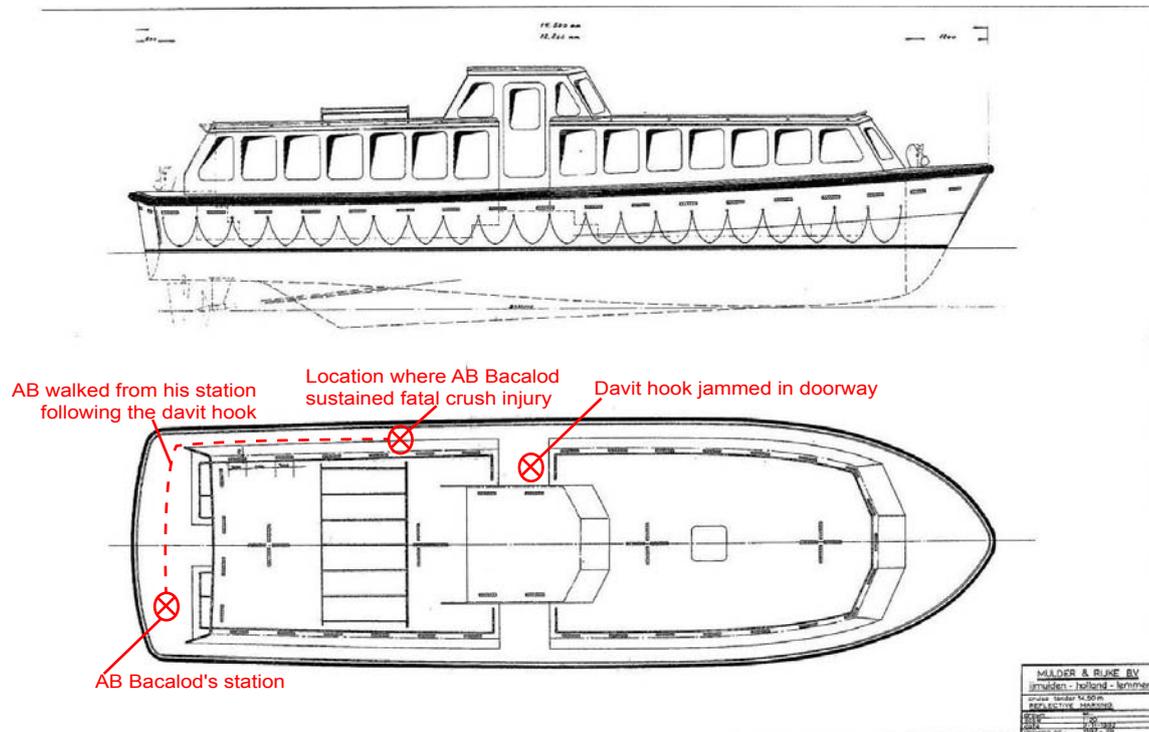
Figure 5

*Thomson Celebration* had 16 lifeboats. *Tender 15*, the aftermost boat on the starboard side, was one of four that were also designated as passenger tenders (**Figure 5**). The design of the launching and recovery equipment for the passenger tenders was the same as for the conventional lifeboats. However, this equipment had been strengthened to take into account the greater weight of the passenger tenders and fitted with mechanical lowering capability (**Figure 6**). The tenders were equipped with twin inboard engines and twin rudders; this made them fast and very manoeuvrable.

Seating plans of Passenger Tender on Thomson Celebration
